Fatigue Failures in Aeroengine Components

S.K. Bhaumik*

Failure Analysis Group, Materials Science Division
National Aerospace Laboratories Bangalore 560 017.

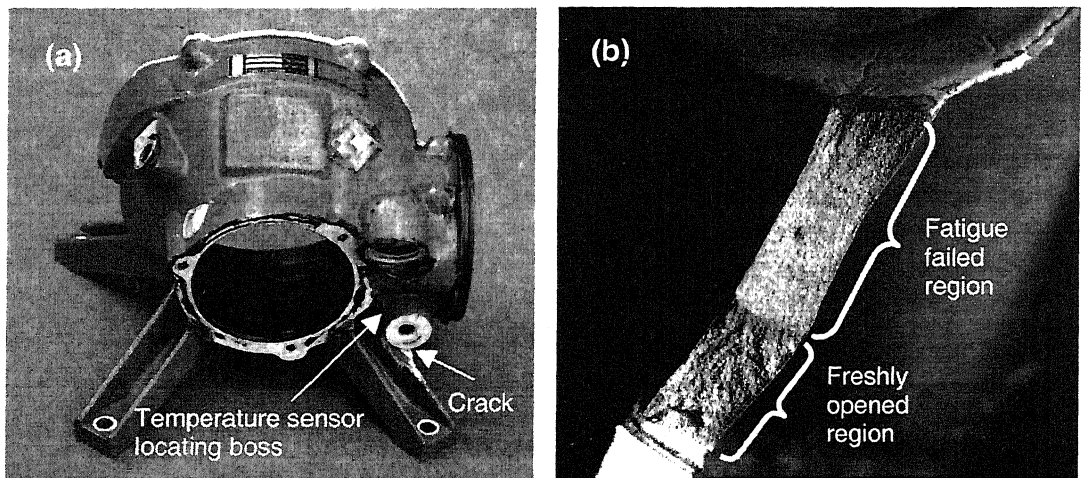
There were a series of failures in tail rotor gearbox (TGB) housing of a particular type of helicopter. In all the cases, premature fatigue crack initiation was noticed at the fillet of one of the mounting lugs of the TGB housing (Fig. 1). It is important to note that the fatigue crack was located at the fillet of the fusing area of the lug with the temperature sensor-locating boss. Investigation revealed no deficiency in the material of construction. The fillet radius was also found adequate.

Analysis showed that the premature fatigue crack initiation was facilitated due to wide difference between the reaction loads in the two webs of the lug. Because of the introduction of the temperature sensor-locating boss, the length of one of the webs was considerably shorter than that of the other one. This had resulted in disproportionate load sharing in the two webs such that the shorter one experienced the majority of the reaction load on the lug. Hence this particular lug was always vulnerable to early fatigue crack initiation. The failure of the TGB housing is, therefore, attributed to the faulty design.

Fig. 1. Photographs showing (a) cracked TGB housing and (b) the fatigue crack surface

A lug with a wide difference in the web lengths is not a good engineering practice. It is desirable that the web lengths are similar so that the reaction loads are equally shared. It was recommended that the temperature sensor-locating boss be relocated to a non-critical region or isolated from the attachment lug. It was also recommended that in unavoidable circumstances, the threshold stress on the shorter web should be the design criterion.

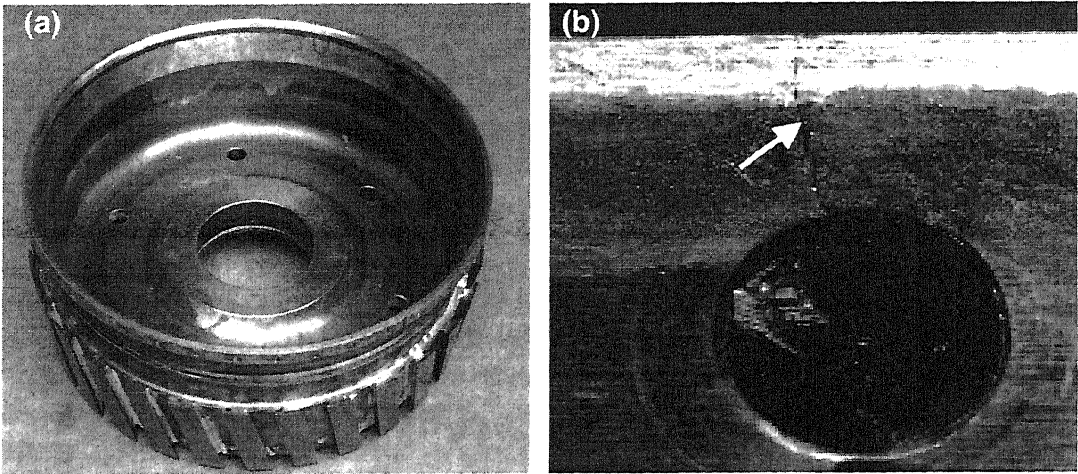
A second stage compressor rotor drum had developed cracks at the rivet holes (Fig. 2). Presence of beach marks on the fracture surface (Fig. 3a) and striations revealed by electron fractography (Fig. 3b) confirmed that the compressor drum had failed by fatigue, the crack initiating at the surface of the rivet hole. The fatigue crack initiation on the rivet hole surface

Fig. 2. Photograph showing (a) cracked second stage compressor drum and (b) close-up view of the crack at the rivet hole (arrow)

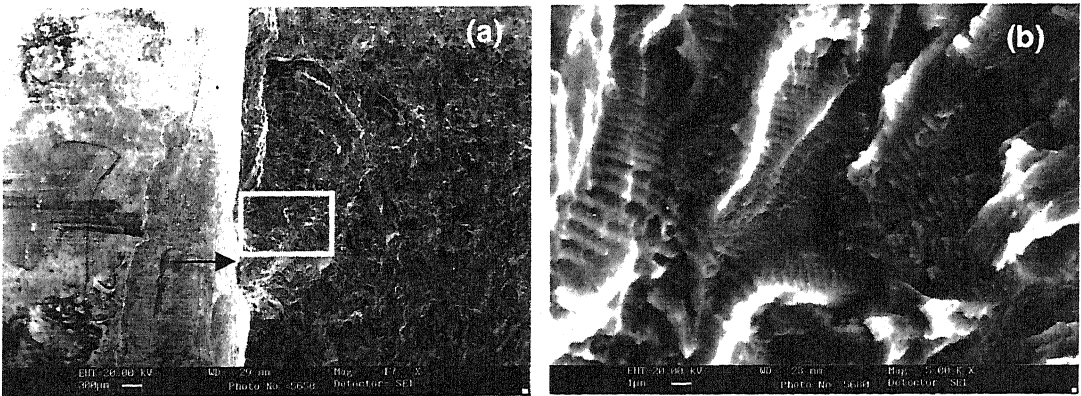
and not at the edge is unusual and cannot occur unless there is stress concentration at this location.

Fig. 3. Scanning electron fractographs showing (a) crack origin (arrow) on the rivet hole surface and (b) fatigue striations in the region marked by a rectangular box in (a).

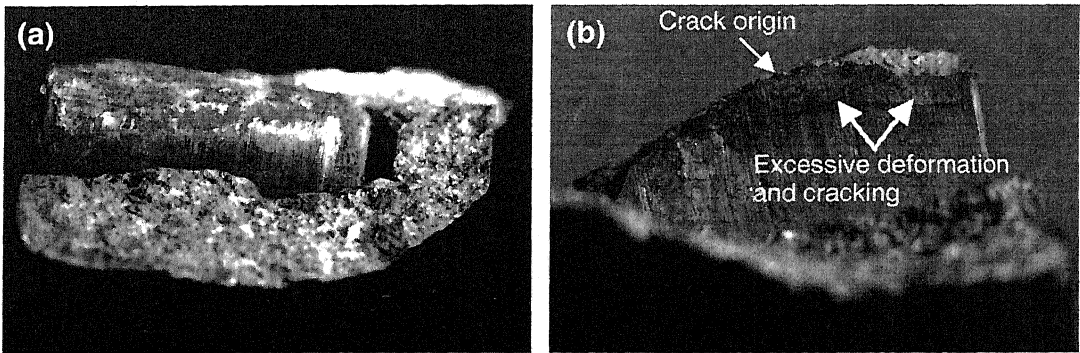
The cause of failure can be understood from Fig. 4, which shows improper contacts of the rivet with the rivet hole surface on the drum. This had resulted in severe localized deformation and generation of cracks in the drum material. The fatigue crack had initiated at these stress raisers.

Fig. 4. Photographs showing (a) non-uniform contacts on the rivet and (b) localized deformation and cracking on the rivet hole surface.

In blind fasteners such as the present ones, if the hardness of the rivet and the drum is of the same order, the tolerances on the rivets and the rivet holes are very critical and if not maintained properly, the problem of improper contact between the rivets and the rivet holes, as seen in the present case, is inevitable. On the other hand, if the rivet has lower hardness than that of the drum material, the tolerances are less critical and are normally taken care of due to deformation of the rivets during the riveting operation. As per the specification, the compressor drum and the rivets are made of titanium alloy and steel respectively, and have similar hardness. Therefore, the failure was due to improper manufacturing of the drum and/or the rivets wherein the tolerances on the rivet/rivet holes in terms of clearance and ovality were not maintained as required.

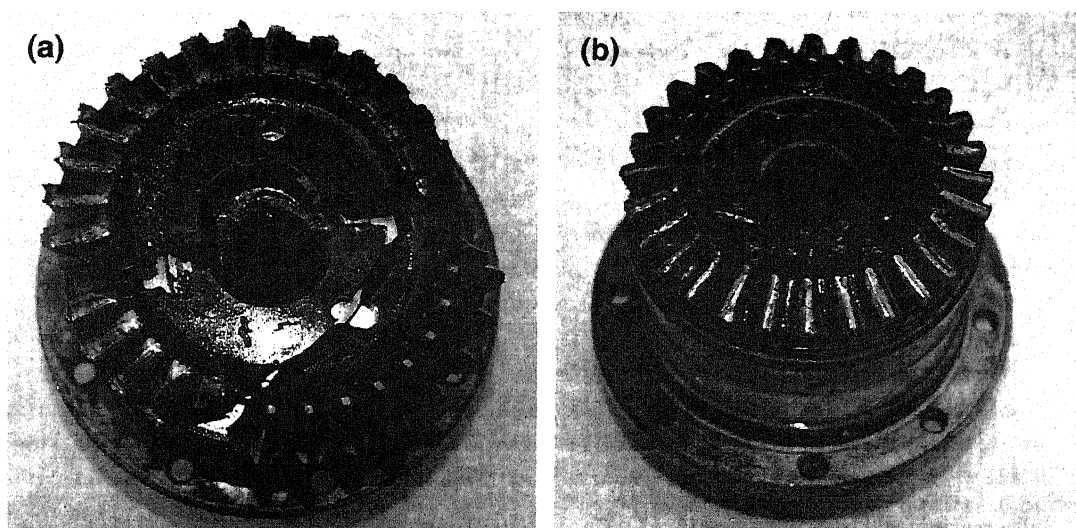
Strip examination revealed that the driving gear had fractured into three pieces and the teeth on the driven gear were completely damaged (Fig. 5). Fractographic study confirmed that the driving gear had failed by fatigue (Fig. 6). There were severe wear and material flow on the loading flank of the teeth (Fig. 7a). This is typical of destructive wear and indicative of excessive load on the gear teeth, in general. On the non-loading flank, minor polishing wear was observed on a localized region (Fig. 7b). As far as the functioning of the gear in the intermediate gearbox is concerned, it rotates in one direction. Therefore, the wear on the non-loading flank is unusual and can occur only when the gears do not mesh properly. Improper meshing of the gears also implies misalignment in the assembly. Any misalignment in the gear train, including the drive shaft, may result in extraordinary high loads on the gear, and may, therefore, lead to rapid failure by fatigue mechanism.

Fig. 5. Photographs of (a) fractured driving gear and (b) damaged driven gear

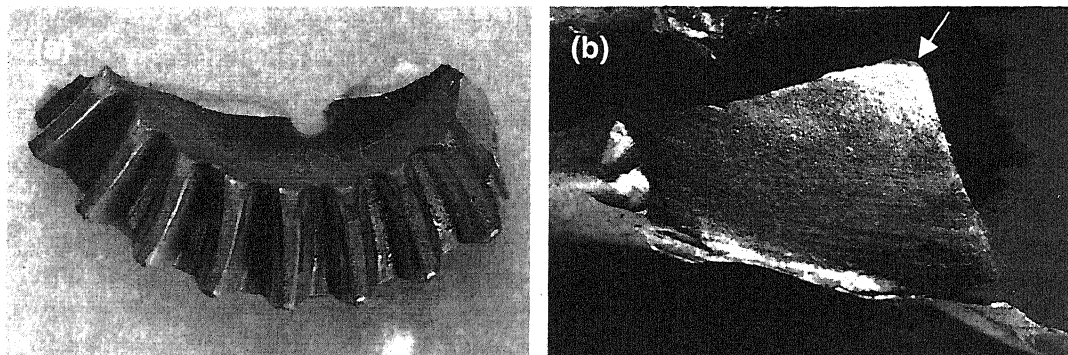
Fig. 6. (a) A part of the fractured driving gear and (b) beach marks on the fracture surface, typical of fatigue; arrow indicates crack origin

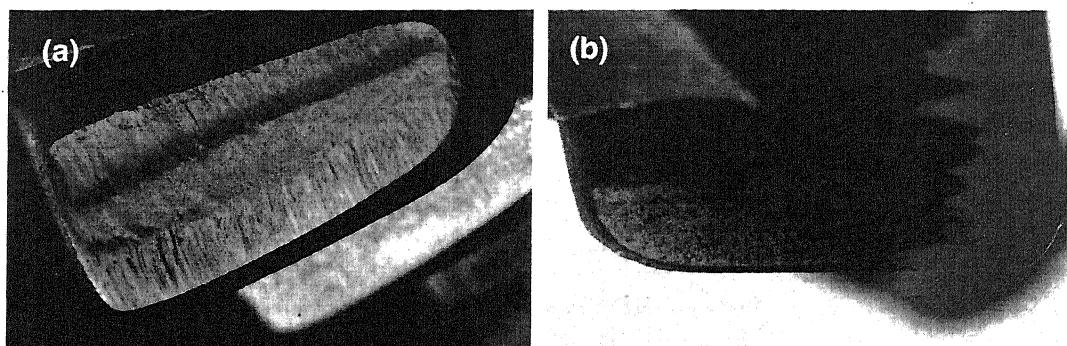
Fig. 7. (a) Destructive wear on the loading flank and (b) polishing wear on a localized region of the non-loading flank (shiny)

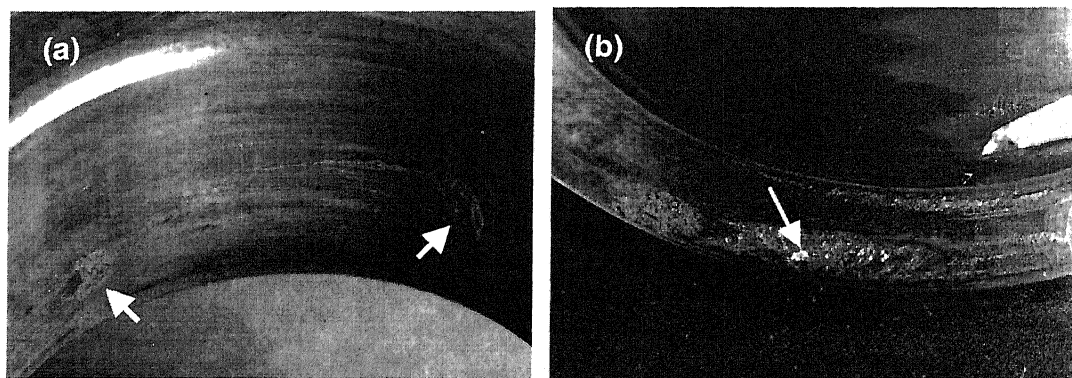
Fig. 8. Photographs showing fretting (arrows) on (a) bore surface of the roller bearing and (b) flange of the gear in contact with the bearing

In view of the above, when the gear assembly was dis-assembled and subjected to inspection, fretting was observed on the bore surface of the roller bearing and at the corresponding location on the driving shaft (Fig. 8). Fretting is a wear phenomenon that occurs between two mating surfaces and is adhesive in nature. Generally, fretting occurs between two tight-fitting surfaces such as the present one that are subjected to a cyclic, relative motion of extremely small amplitude. It may be noted that the fretting surfaces are never intended to undergo relative motion.

It is, therefore, established that the roller bearing on the driving shaft was not assembled properly. There was relative movement between the shaft and the bore of the bearing resulting in fretting damage. Once sufficient clearance was established due to fretting, gear probably

began pounding (low amplitude) on the driven gear causing excessive load on the teeth. This in turn had resulted in excessive wear on the loading flank as well as fatigue failure of the gear.

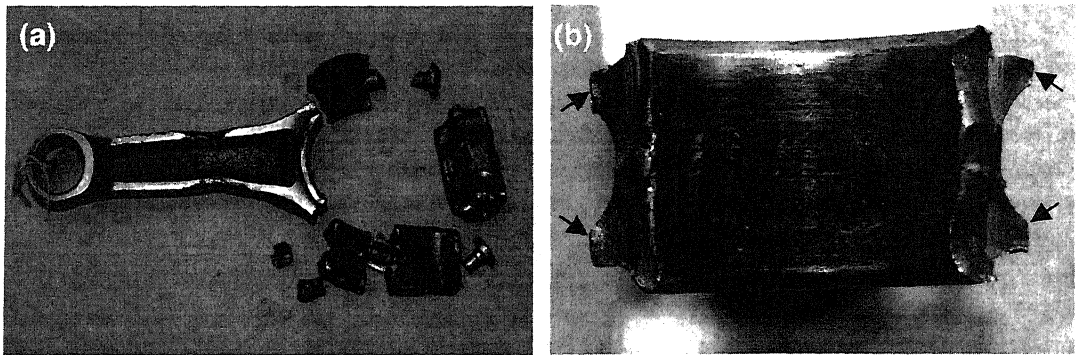
There were a series of accidents to a type of aircraft. The aircraft was fitted with six-piston engine and all the accidents were reported to have taken place due to engine failure. The failures were identical and in each case, one of the six connecting rods was found fractured into pieces (Fig. 9a), while there were no significant damages to the remaining five connecting rods. Fractographic examination confirmed that the connecting rod had failed by fatigue (Fig. 9b). Four fatigue cracks had initiated at the bolt cut out surfaces near the big cap and had progressed simultaneously over a period of time. Once these cracks had reached critical lengths, the big cap of the connecting rod had detached leading to extensive damage to the engine. One of the attachment bolts of the big cap had fractured into two pieces under bending overload. The other attachment bolt had fractured into three pieces on impact and the shank of the bolt could not be retrieved from the wreckage.

A detailed study of the failed connecting rod was carried out to establish the sequence of failure in the engine. It was found that though there were four fatigue cracks at the four corners of the web of the connecting rod, one side of the web gave away first resulting in the lifting up of the big cap. It was conclusively proved that the attachment bolts were properly tightened and they had no role to play in the failure. Detailed investigation showed that the connecting rod failure was because of inadequate lubrication arising from loss of oil pressure. The loss of oil pressure was traced to faulty flying of the aircrafts. Following this investigation, the flying syllabus was revised and the problem was solved.

Fig. 9. (a) Fractured connecting rod and (b) fatigue crack origins (arrows) at corners of the web

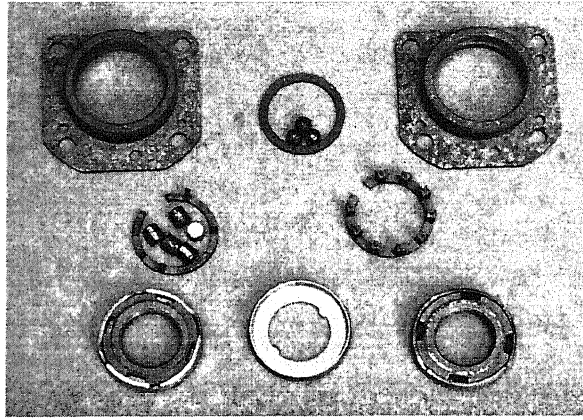
There was an incidence of bearing failure in the supercharger gearbox of an aeroengine. It was a roller bearing. Examination showed that many of the rollers were heavily damaged and had got kneaded to spherical shape (Fig. 10). These bearings were lubricated by a jet of oil. There had been a modification in the design of the locking cup washer and all the failures had occurred in the post-mod version. Examination of the drawing revealed that to avoid fatigue crack initiation, the passage meant for lubrication was blocked by welding (Fig. 11). As a result of modification, the bearings had suffered lubricant starvation leading to failure. This case amply illustrates the ill effects of ad-hoc alteration of design.

Fig. 10. Damaged bearing components

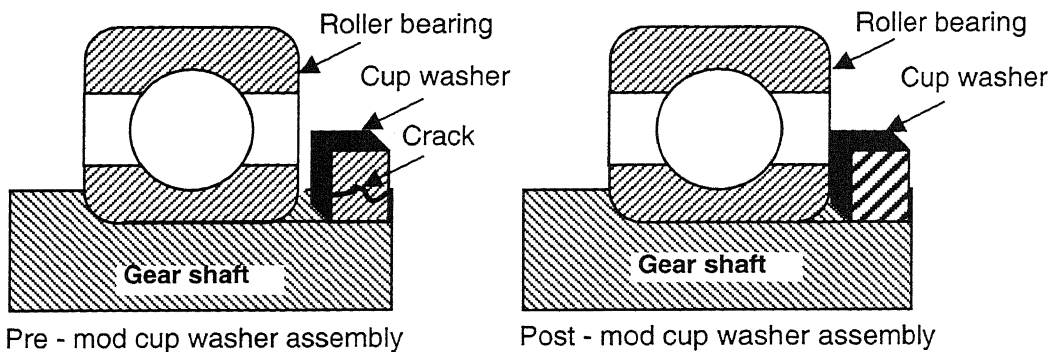
Fig. 11. Schematics showing (a) pre-mod and (b) post-mod cup washer assembly
